## Errata Sheet V1.0

**AT91  
ARM<sup>®</sup> Thumb<sup>®</sup>  
Microcontrollers**

**AT91M63200  
AT91M43300  
Errata Sheet  
V1.0**

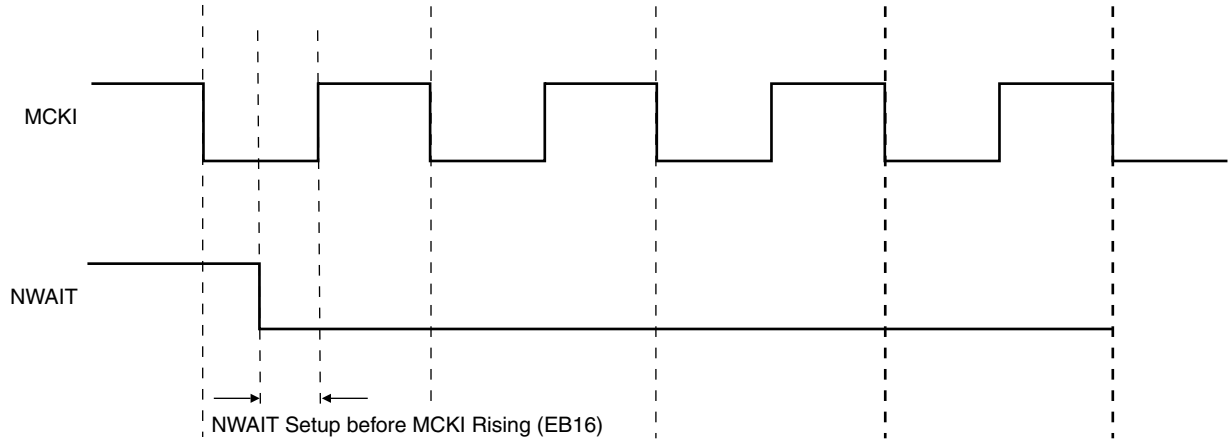
**Figure 1. NWAIT Rising**

If the NWAIT setup time is satisfied on the first rising edge of MCKI, the behavior is accurate. The EBI operations are not affected when the NWAIT rises.

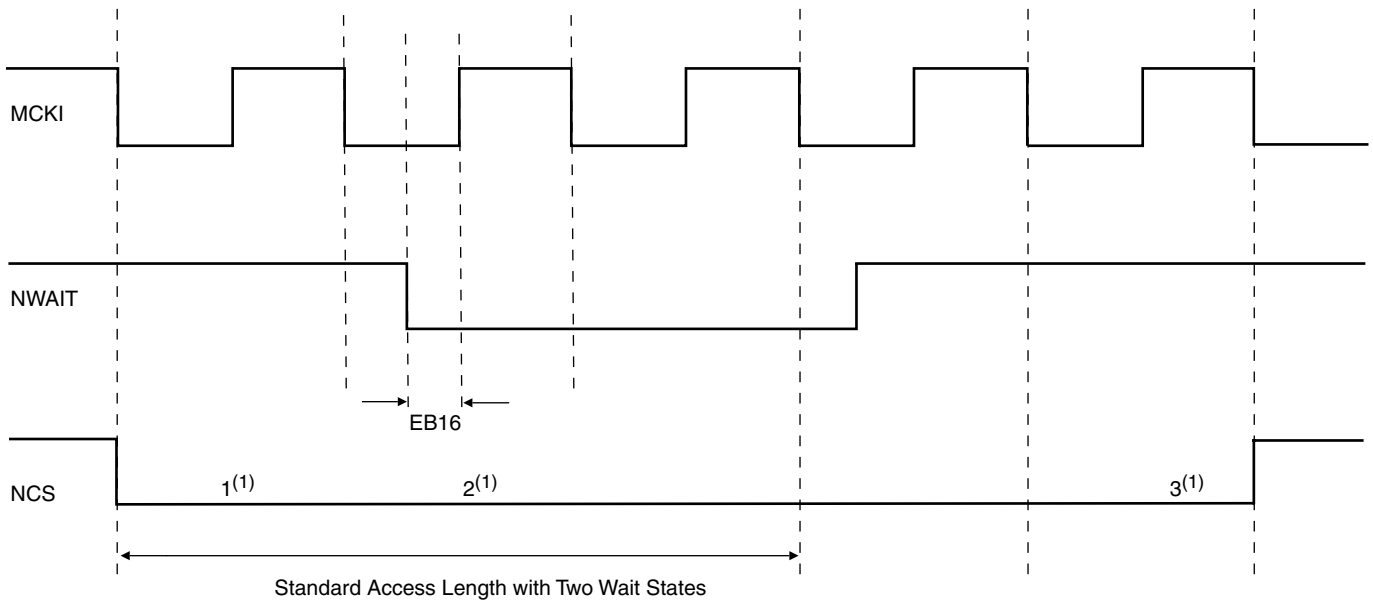
**Figure 2. Number of Standard Wait States is Two**

If the NWAIT setup time is satisfied on the following edges of MCKI and if at least one standard wait state remains to be executed, the behavior is accurate. In the following example, the number of standard wait states is two. The NWAIT setup time on the second rising edge of MCKI must be met.

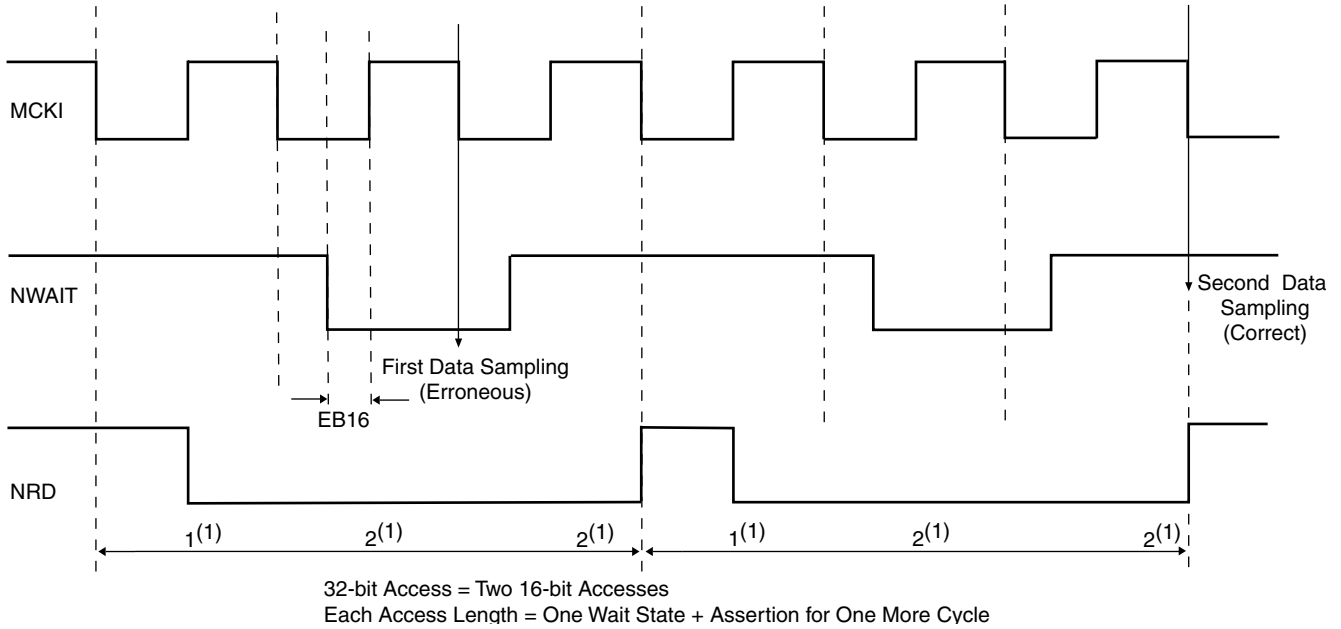
**Figure 3.** Number of Standard Wait States is One

If the first two conditions are not met during a 32-bit read access, the first 16-bit data is read at the end of the standard 16-bit read access. In the following example, the number of standard waits is one. NWAIT assertions do affect both NRD pulse lengths, but first data sampling is not delayed. The second data sampling is correct.

At maximum speed, asserting the NWAIT in the first access cycle is not possible, as the sum of the timings “MCKI Falling to Chip Select” and “NWAIT setup to MCKI rising” are generally higher than one half of a clock period. This leads to using at least one standard wait state. However, this is not sufficient except to perform byte or half-word read accesses. Word and write accesses require at least two standard wait states.

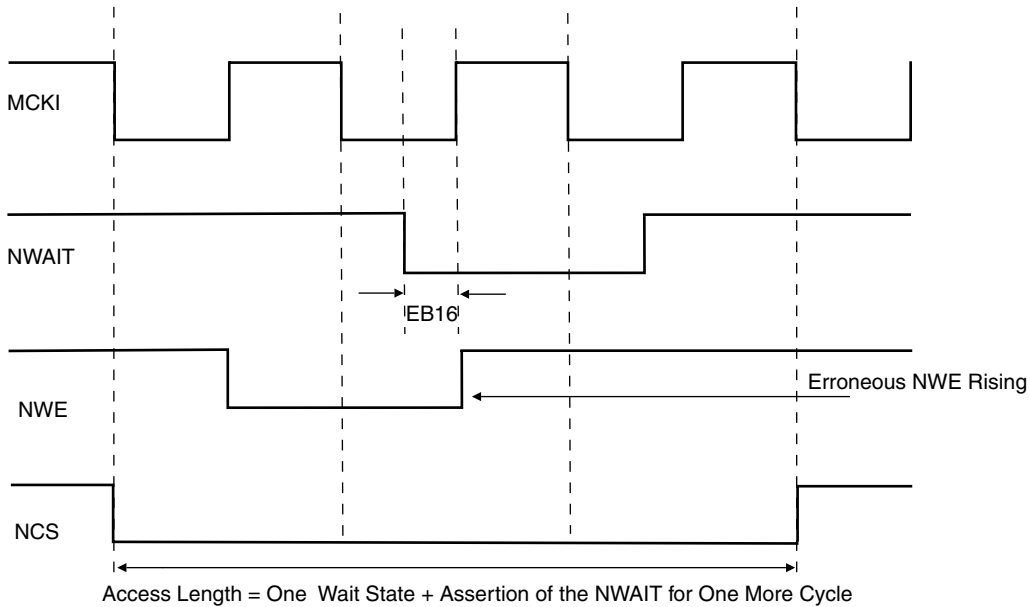
**Figure 4.** Description of the Number of Standard Wait States

If the first two conditions are not met during write accesses, the NWE signal is not affected by the NWAIT assertion. The following example illustrates the number of standard wait states. NWAIT is not asserted during the first cycle, but is asserted at the second and last cycle of the standard access. The access is correctly delayed as the NCS line rises accordingly to the NWAIT assertion. However, the NWE signal waveform is unchanged, and rises too early.
